DRAFT SEDIMENTATION REPORT:

The Laloki River catchment

June 2019

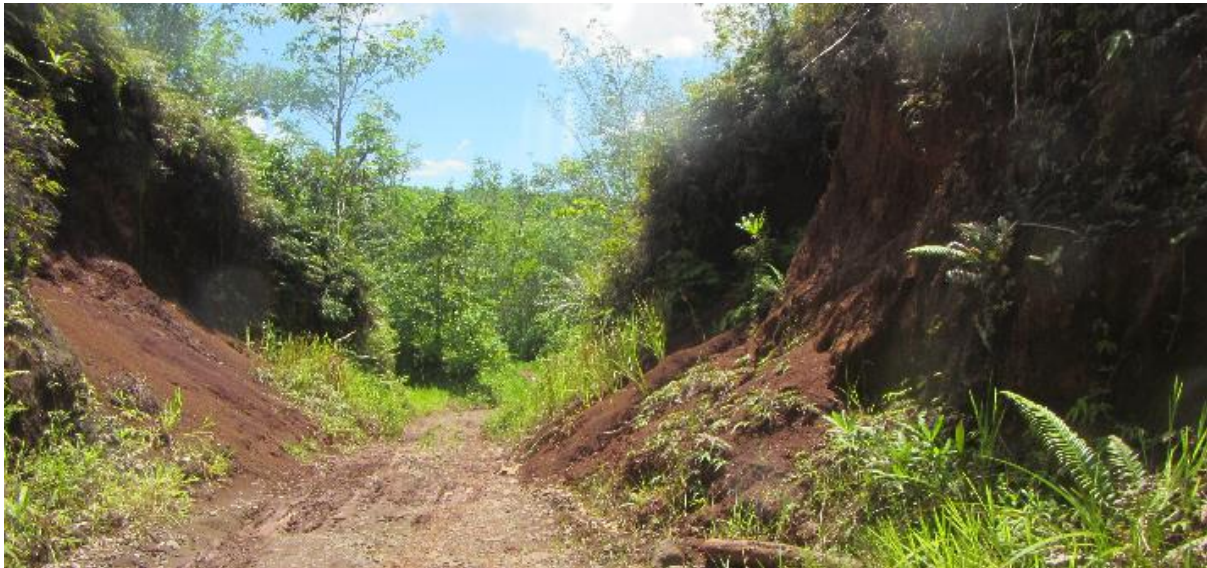
Figure 26 Multiple road cuttings along the Eilogo Creek catchment expose cohesive volcanic clays, leading to sediment slumping and transport along the road during runoff events

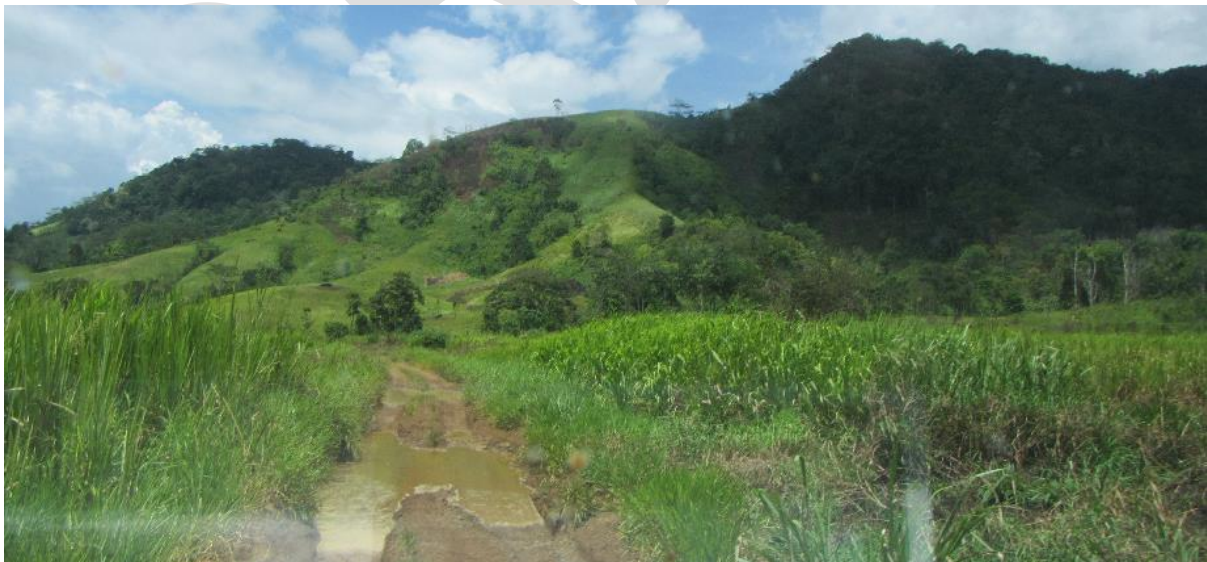
Figure 27 The main access road cuts across multiple floodplain margin swamps which remain sodden even during the dry season. Note the cleared upper slopes in the background, which are burnt to make way for vegetable gardens

The upper section of the Eilogo Creek catchment features small creek-side villages which have developed after logging made way for the establishment of rubber plantations and cattle stations. In this upper section, the creek is bordered by dense riparian zones which give way to rainforest upon cohesive volcanic clays (Figure 26). Small (~1Ha) portions of steeply sloping land are burnt/cleared for intensive horticulture; primarily peanuts, beans and sweet potato (Figure 27). This highland farming style can lead to large losses of the A-ce of up to 70 cm in two years. Similar sized portions of land within flat floodplain margin swamps have also been cleared for intensive horticulture, which in times of flood are likely to lead to further sediment losses. These swampy areas of the valley floor are a major sediment/nutrient sink, which lend to intensive agriculture (Figure 27).

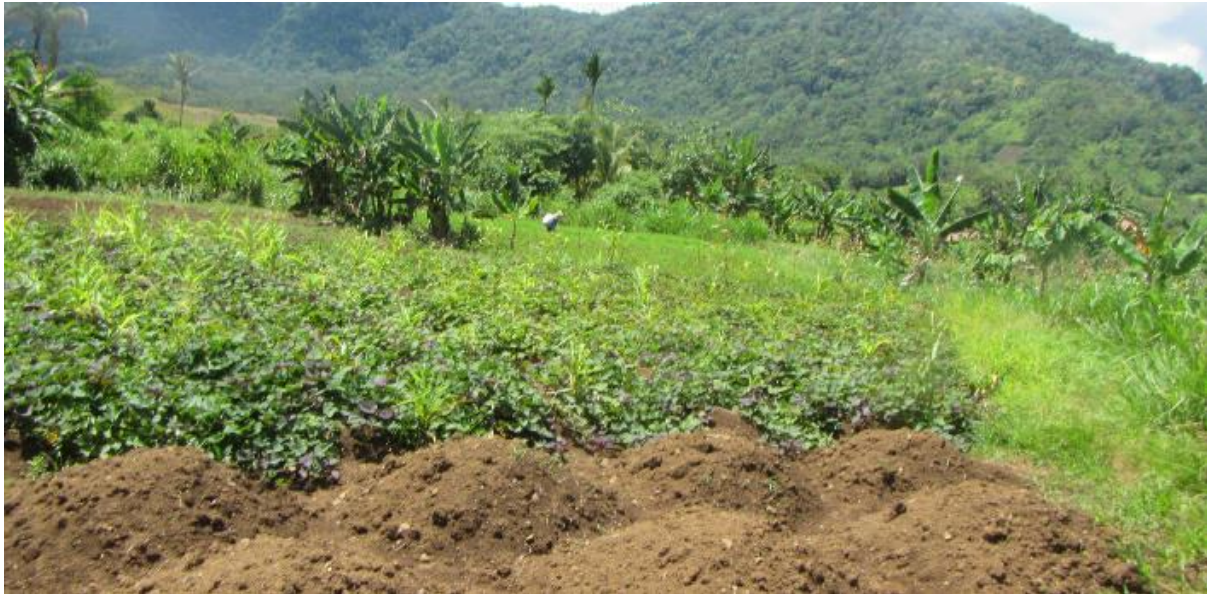
Figure 28 *Intensive horticulture on the floodplain*

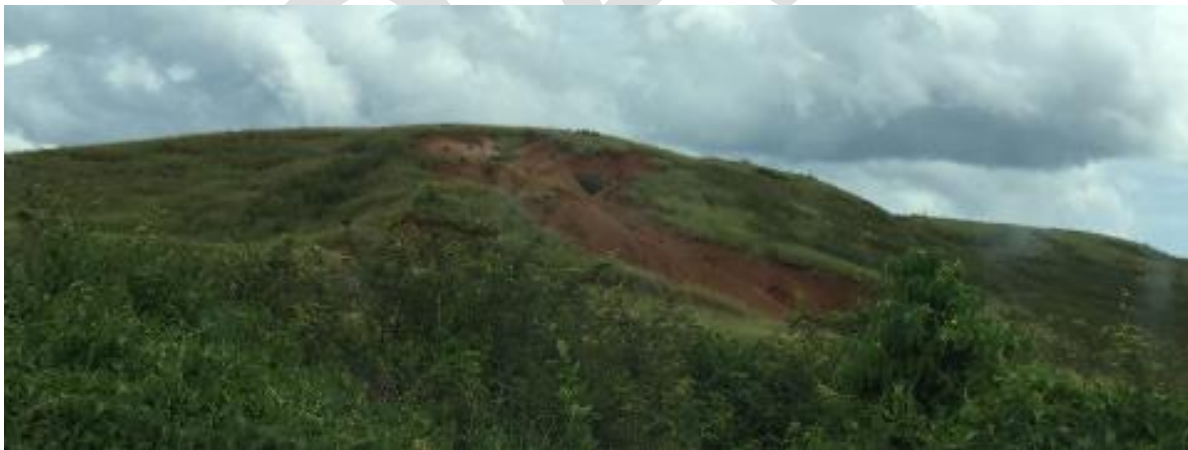
Figure 29 *Exposed gullies on low hills are prevalent within the perimeter of the cattle station particularly where vehicle or animal traffic has concentrated overland flow in steeper sections (March 2019)*

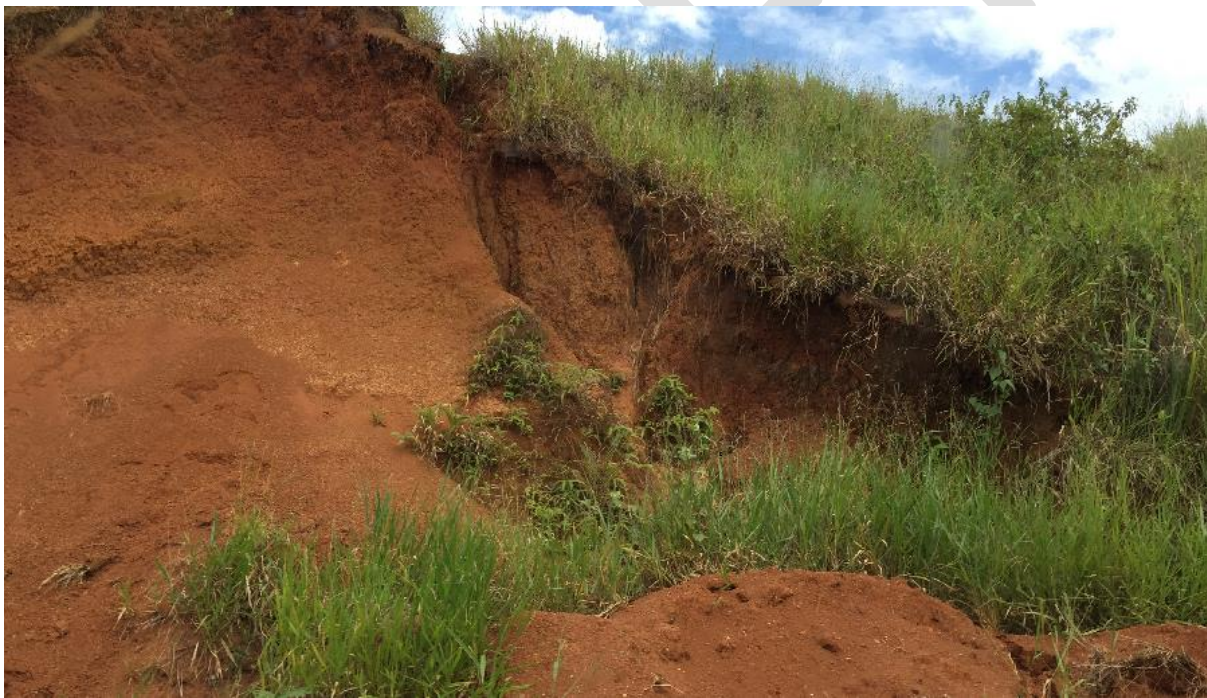
Figure 31 While relatively cohesive, the exposed laterite clay soils are susceptible to mass failure when saturated (March 2019)

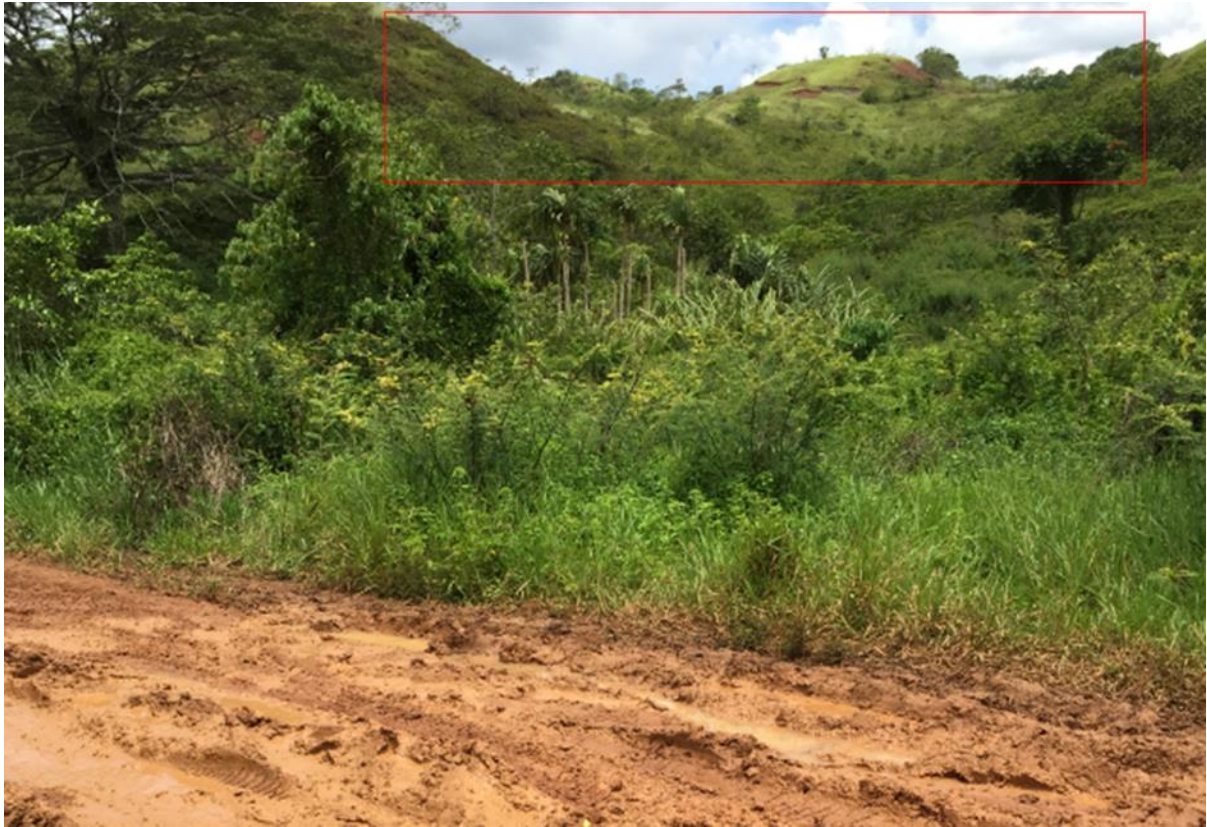
Figure 32 Eilogo Creek road crosses multiple floodplain swamps which are often impassable during the wet season, note the exposed hillslope scalds highlighted in the red box (March 2019)

A major tributary of Eilogo Creek drains a significant portion of the northern escarpment which includes the cattle station, gardens and burnt areas exposed to hillslope erosion (Figure 30 and Figure 33). Proposals for upgrading the beginnings of the Kokoda trail (which is accessed via Sogeri) and the renewal of the vacant cattle station into a world class agricultural food park are likely to lead to further disturbance of the Eilogo Creek catchment, particularly the unsealed access roads, which cut across the floodplain swamps (Figure 32).

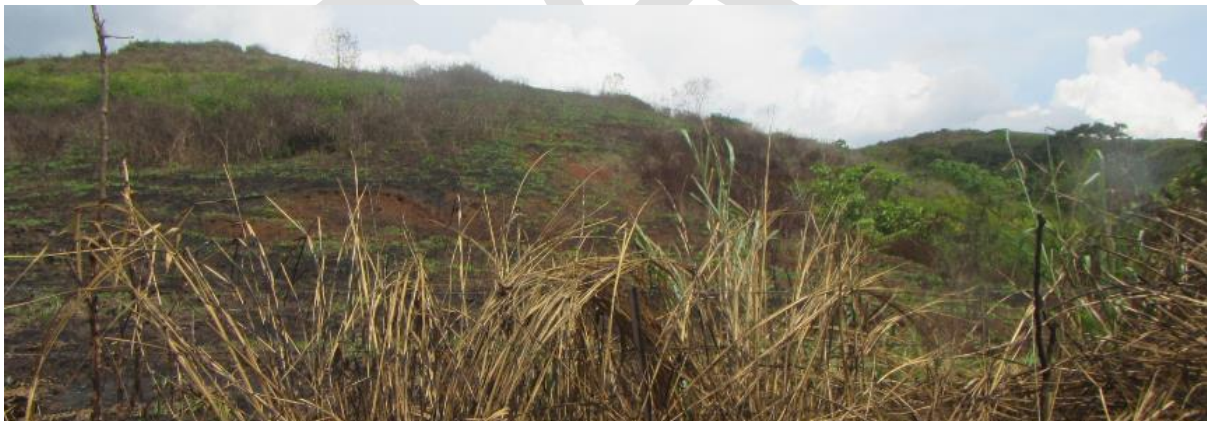
Figure 33 Hillslope burning in the dry season further exposes scalds to rain splash during the wet season, delivering fine sediment into floodplain swamps (Dec 2018)

Land use across the catchment is a mix between forested area and areas cleared for agriculture (i.e. grazing, vegetables, fruits etc.) and minor urban/village settlement. Cleared areas are often quite small (i.e. less than 1 hectare) but also consist of large areas which are periodically burnt. Burnt areas are often situated on steep slopes, which often corresponded with slumped and exposed subsoil (Figure 33 and Figure 38).

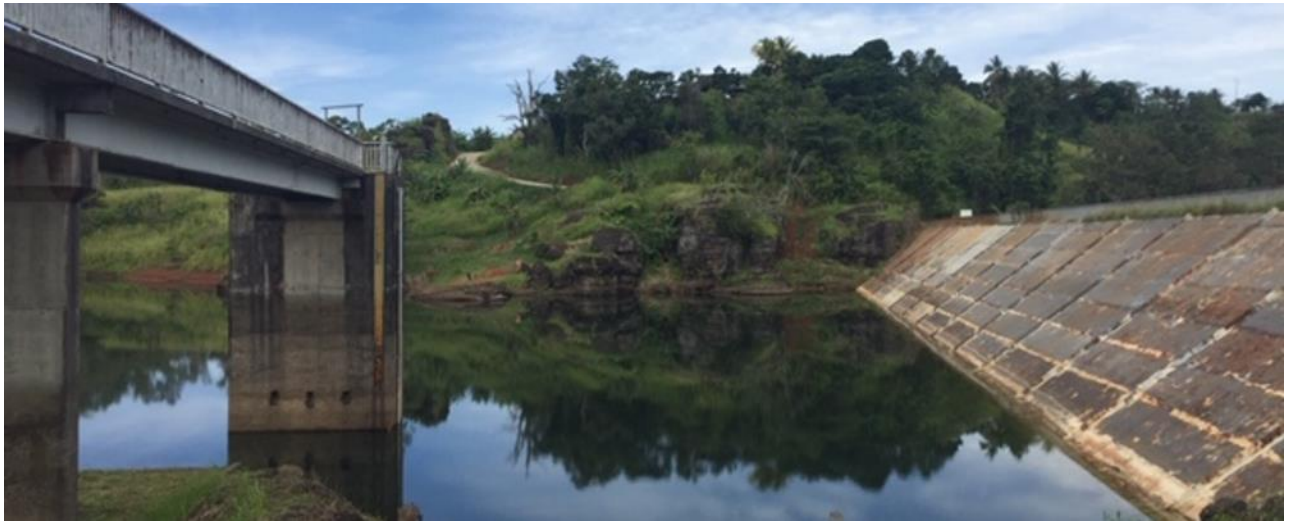
Figure 34 Sirinumu Dam on the 21/3/2019, exhibiting good water clarity during the wet season

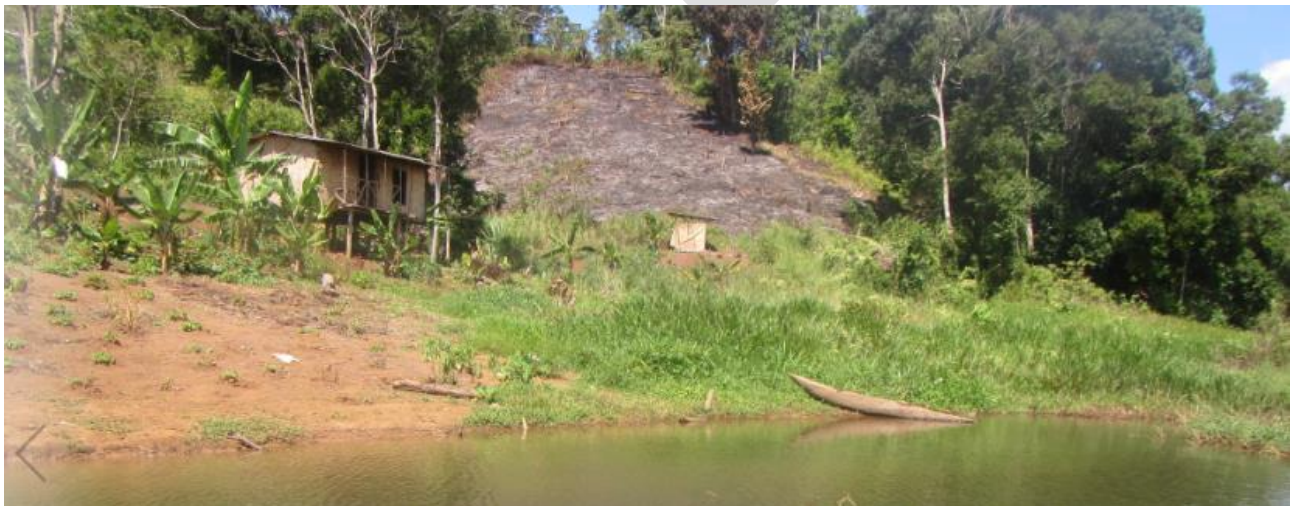
Figure 35 Lake-side cultivation involves the clearing burning of adjacent land

Comprising the upper extent of the Laloki River, the dam catchment is of strategic interest as the primary source of water and hydroelectric power for Port Moresby. Field visits to the catchment did not extend across its forested perimeter but were mainly restricted to vessel-based assessments from within the dam and along the dam wall (Figure 34). The risk of sedimentation within the dam was assessed in 2007 and more recently confirmed to be low (Smith 2007, Alluvium 2018). Sediment sources are likely to derive from lake side cultivation and deforestation from within the catchment in proximity to lakeside settlements (Figure 35).

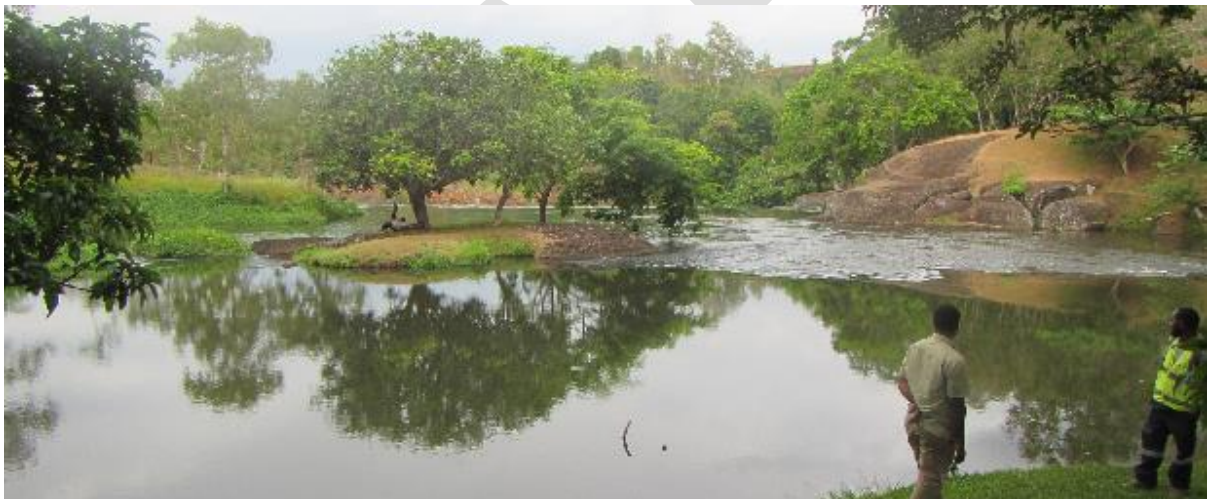
Figure 37 Multiple bedrock exposures along the Laloki River restrict the opportunity for the erosion of floodplain pockets

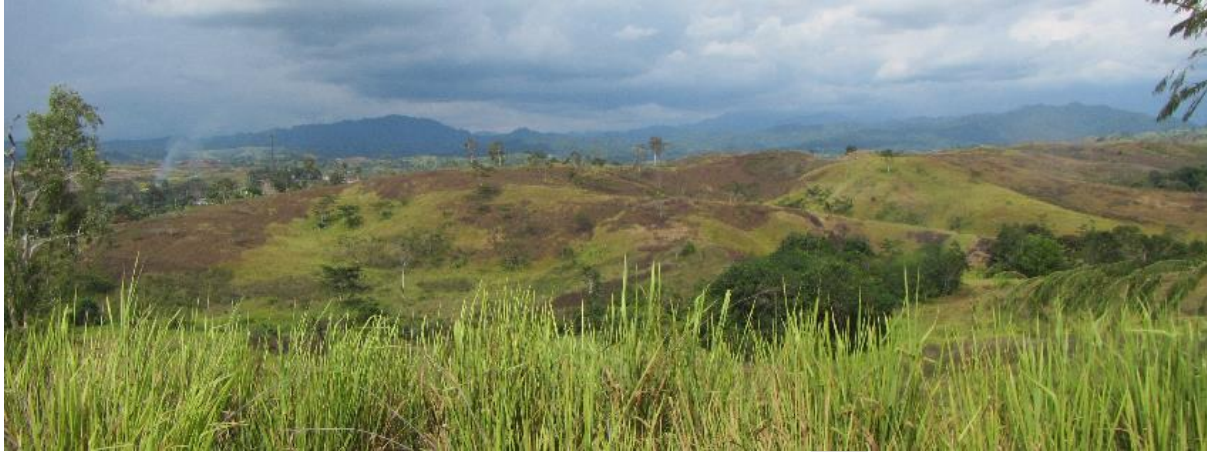
Figure 38 Steep grassy slopes are periodically burnt late in the dry season, exposing soil to wet season rainfall.

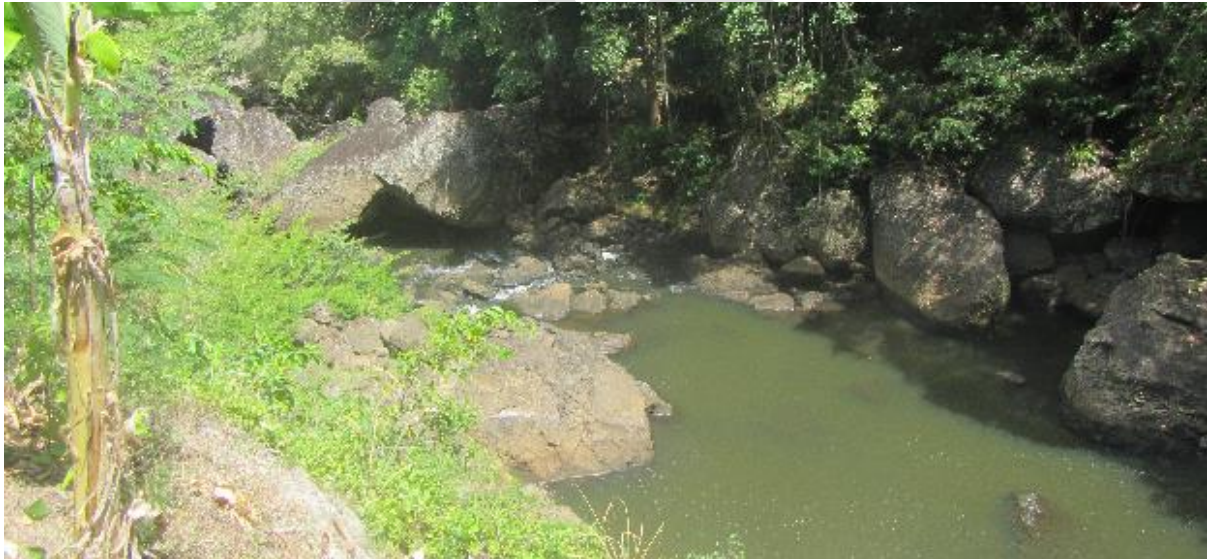
Figure 39 The confined valley setting of Rouna Gorge lends itself to high sediment transport potential with little to no opportunity for deposition within the valley

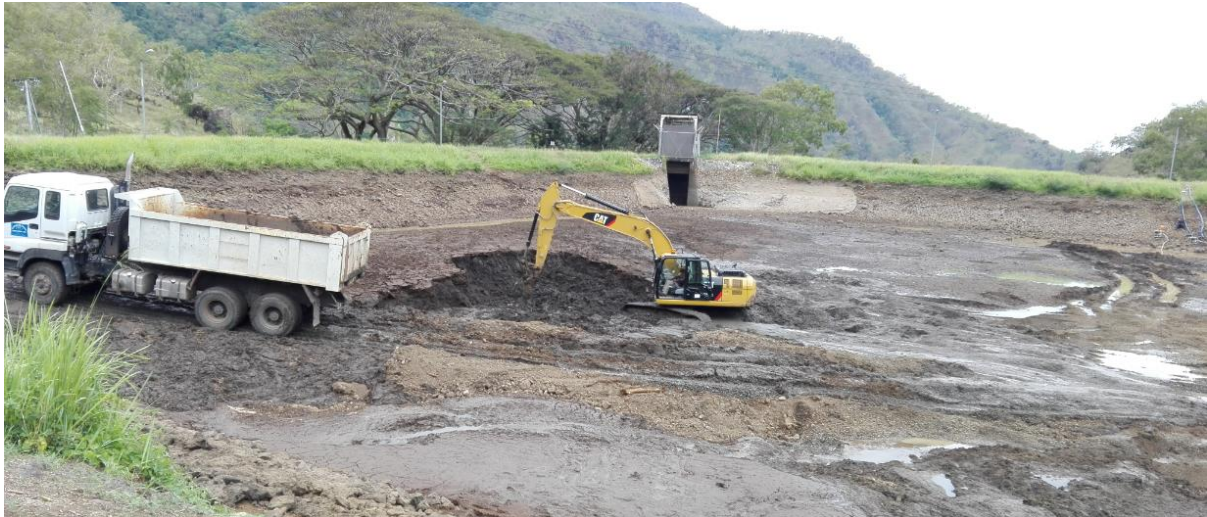
Figure 40 Removal of sediment from the first of two holding ponds along Rouna Gorge (Dec 2018).

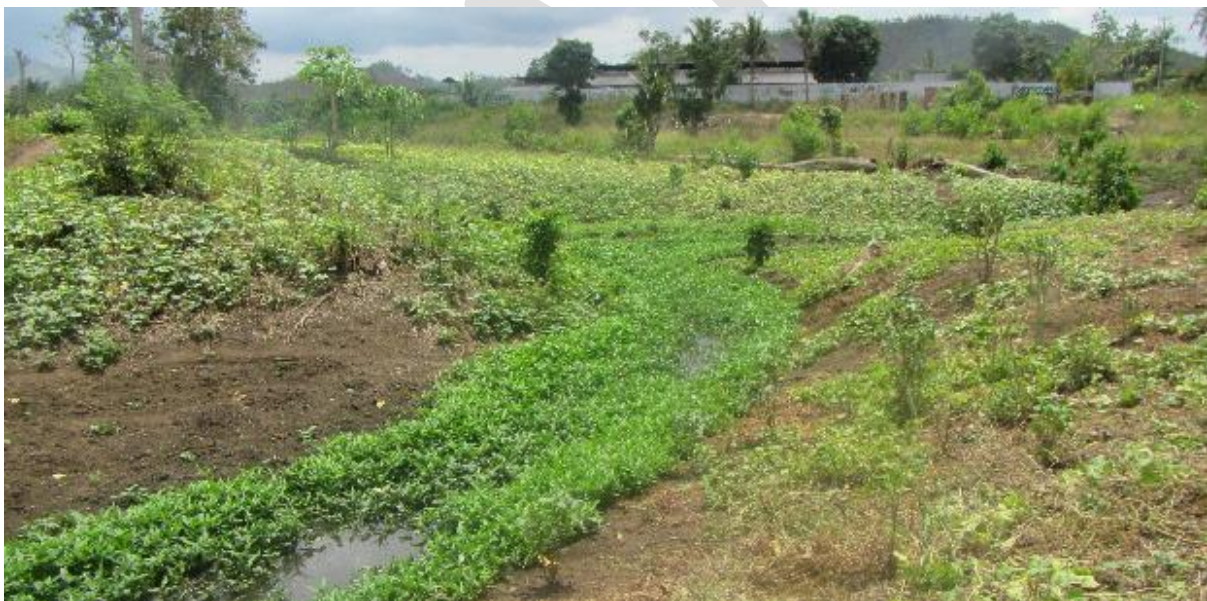
Figure 41 The back fence of the piggery in the background, from where the effluent in the drain pictured, flows into the Laloki River

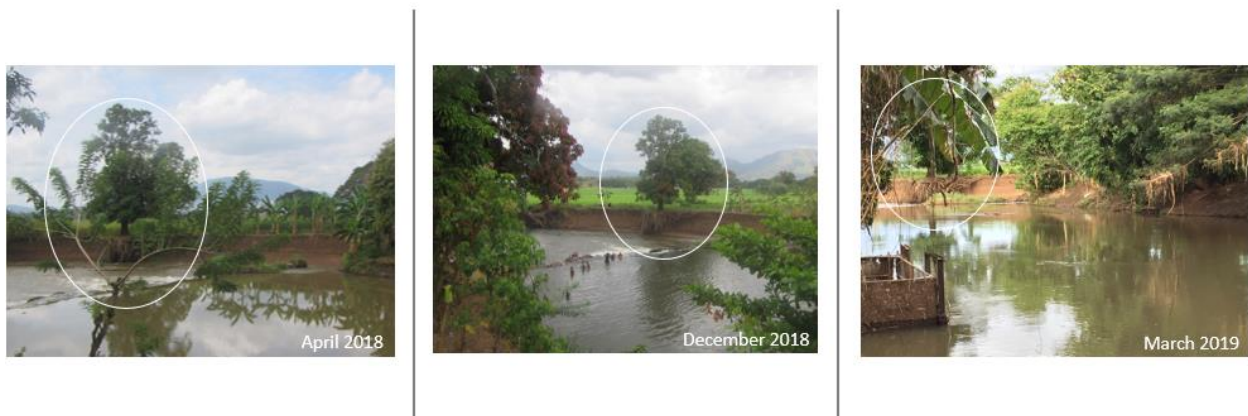
Figure 42. Three consecutive visits over 12 months illustrate the cohesive nature of the stream bank at Bomana pump station, where the circled tree remains insitu despite an extensive flood event in mid-February 2019.

Evidence of bank erosion at the pump station weir was observed during the field investigation with the bank being vertical with exposed clays (Figure 44). Imagery from all three field visits indicates that there wasn't a large degree of change in streambank condition during this period, despite significant floodwaters which swept through the catchment during the December to March wet season in mid-February.

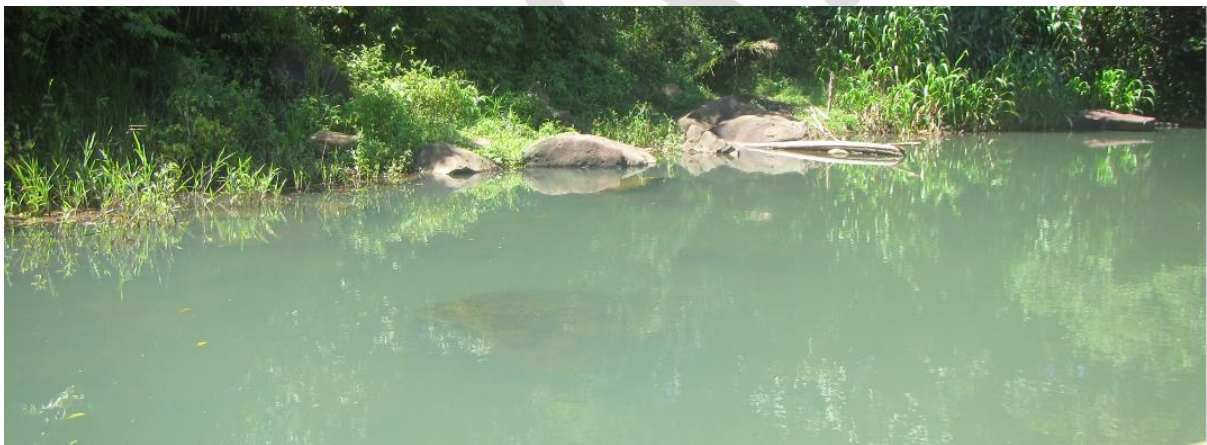
Figure 45. Upstream of Sirinumu Dam (April 2018)

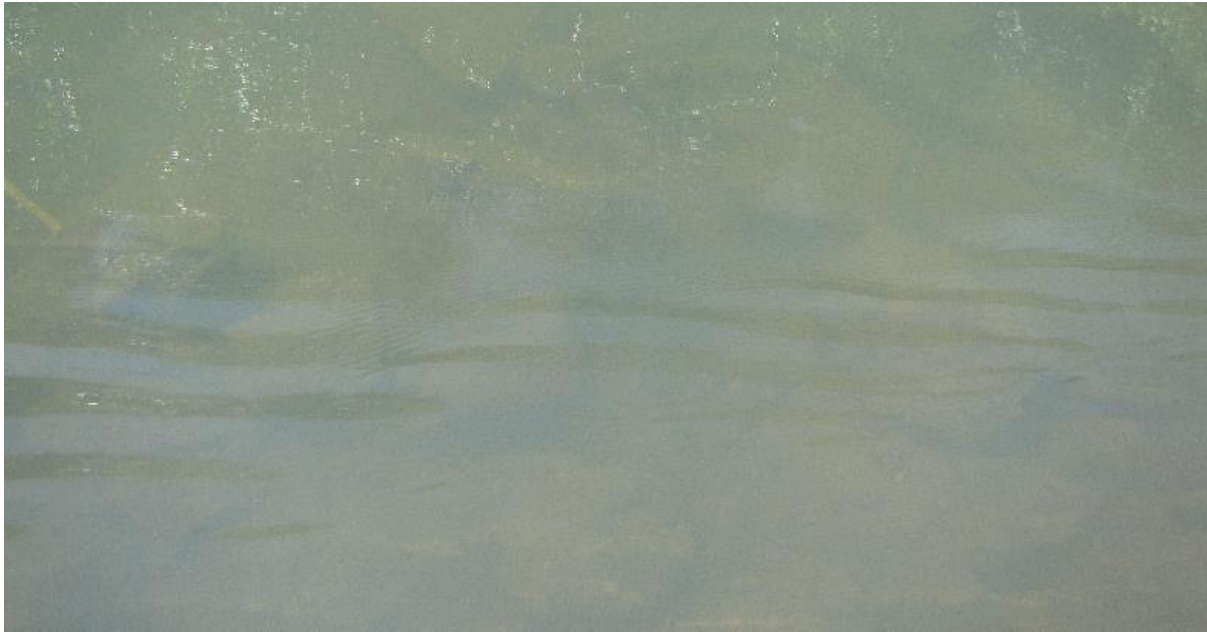
Figure 46. *Cobbles and boulders in the bedload and the clarity of the water are shown in the upper most reaches of the dam inlet (April 2018)*

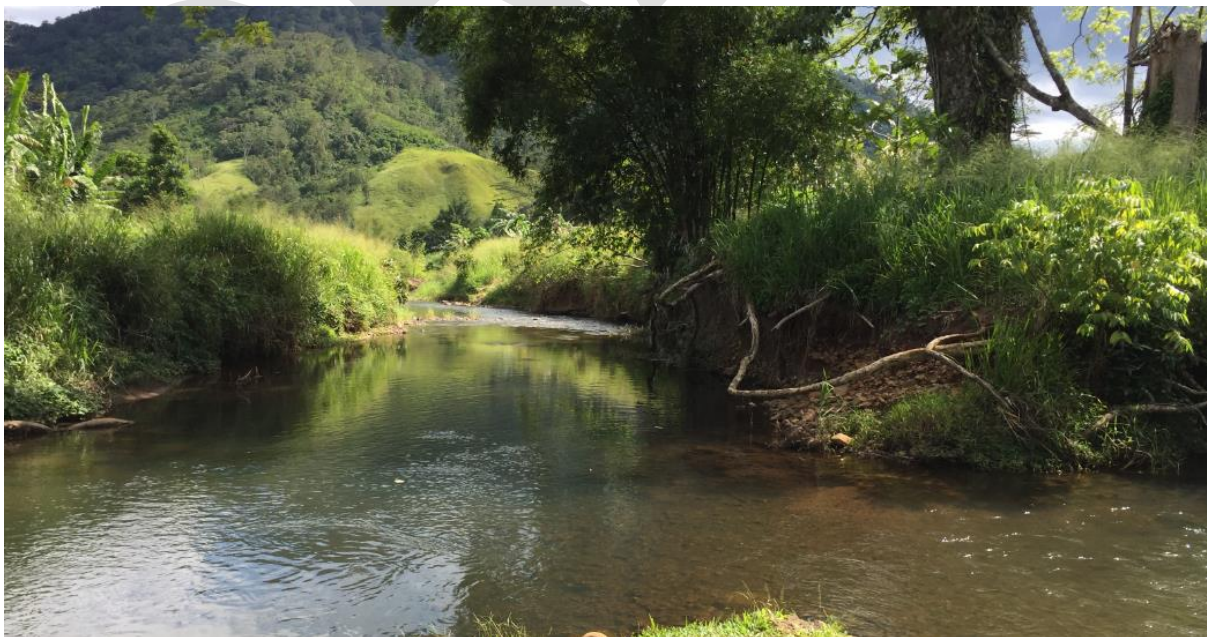
Figure 47. *At the confluence of a minor tributary and upper Eilogo Creek, with a bedload comprised of primarily cobbles and gravels and some boulders amidst a sandy to fine matrix. Photo located by the blue cross in Figure 52*

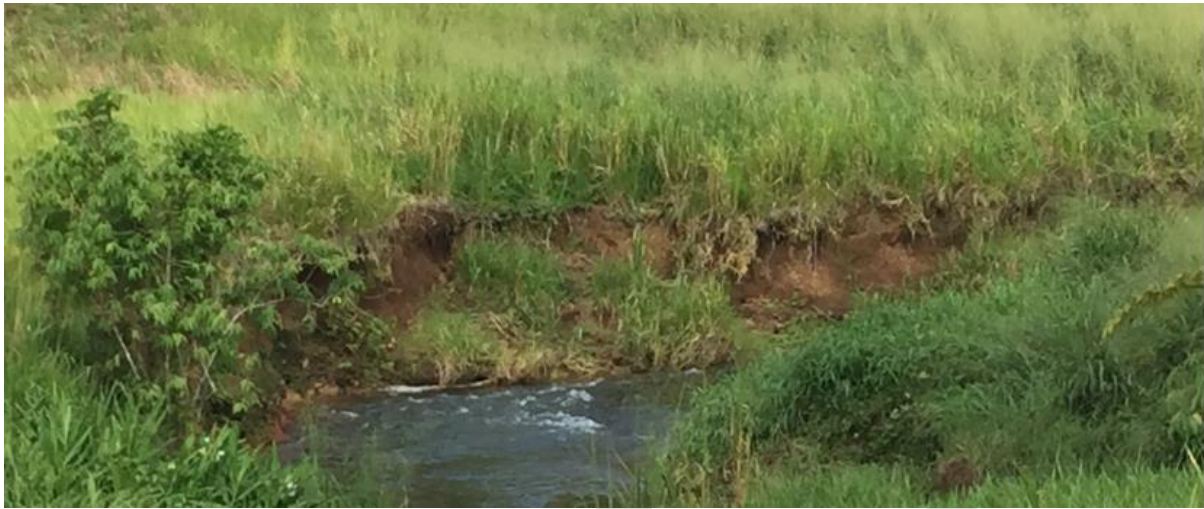
Figure 48. An example mass failure at an outer bend of Eilogo Creek, contributing to the meander development

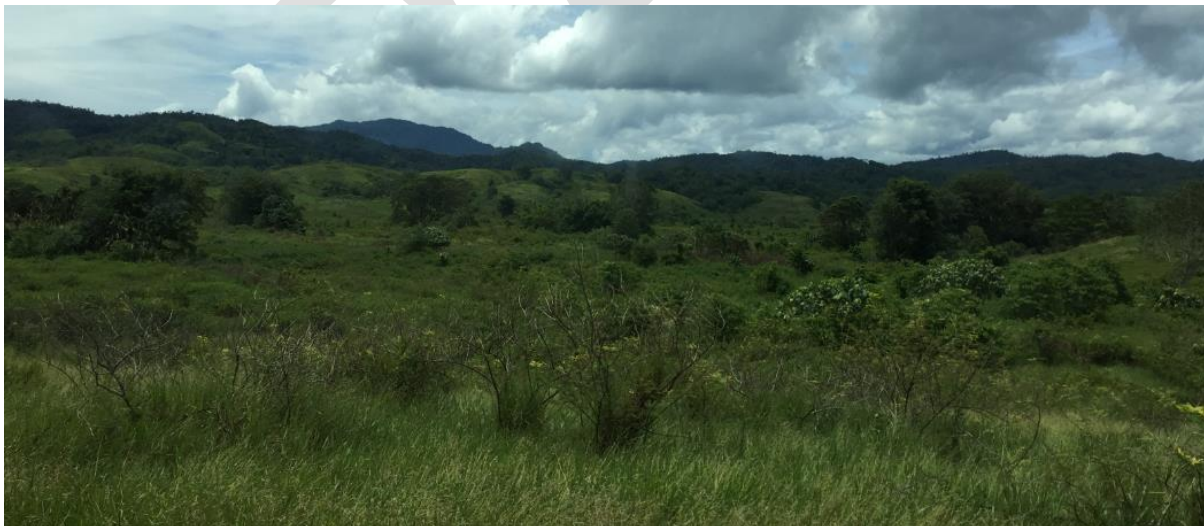
Figure 49 A view from the road looking across the floodplain and margin swamp land, through which the Eilogo Creek meanders. Photo located by the green cross in Figure 48

Further downstream Eilogo Creek is predominantly partly confined, where meander development and migration of the main channel across the floodplain is likely to generate and mobilise sediment downstream (Figure 49). Approximately mid-way along the catchment, the creek is unconfined where broader sections of floodplain margin swamp line tributaries which run off the bordering escarpment. Evidence of pig disturbance was noted within this section, left unchecked, such activity can lead to increased erosion and altered hydrology (Strauch et al., 2016).

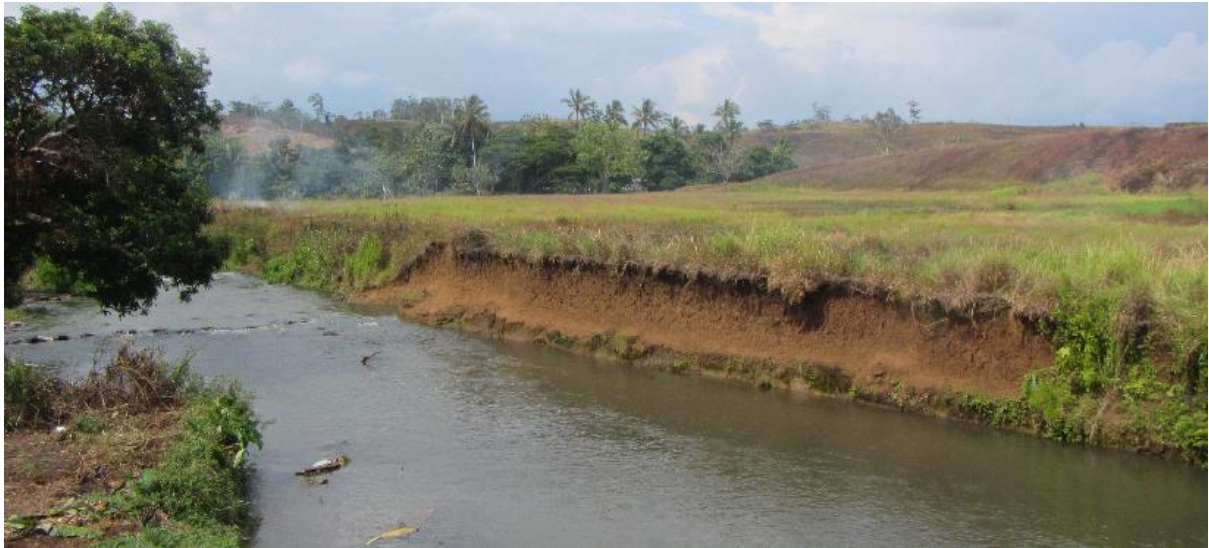
Figure 50. The hillslope rises in the background are expressions of the bedrock controls which guide lower Eilogo Creek toward its confluence with the Laloki River at Sogeri. Photo located by the yellow cross in Figure 48.

Eilogo Creek experiences increasing bedrock controls as it makes its way to Sogeri before its confluence with the Laloki River, with a bedload comprising of fines, gravels and sands with rockier sections where bedrock becomes exposed at hillslope abutments (Figure 50). At Sogeri, local landholders practice erosion control measures through the staking of susceptible banks with live branches to establish riparian vegetation (Figure 51).

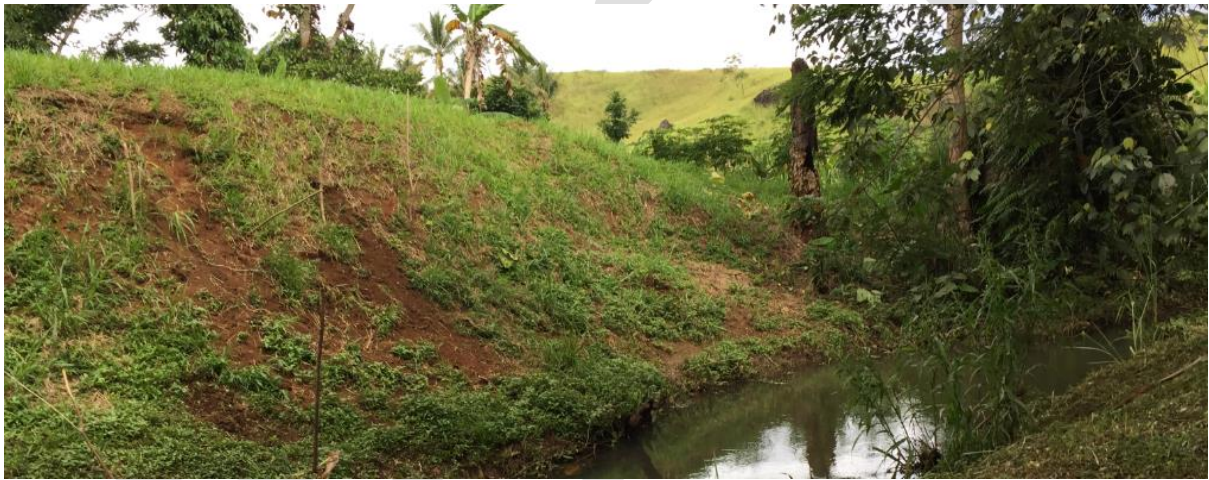
Figure 51. Staking of an eroding bank with live branches as an erosion control measure by local landholders in Sogeri.

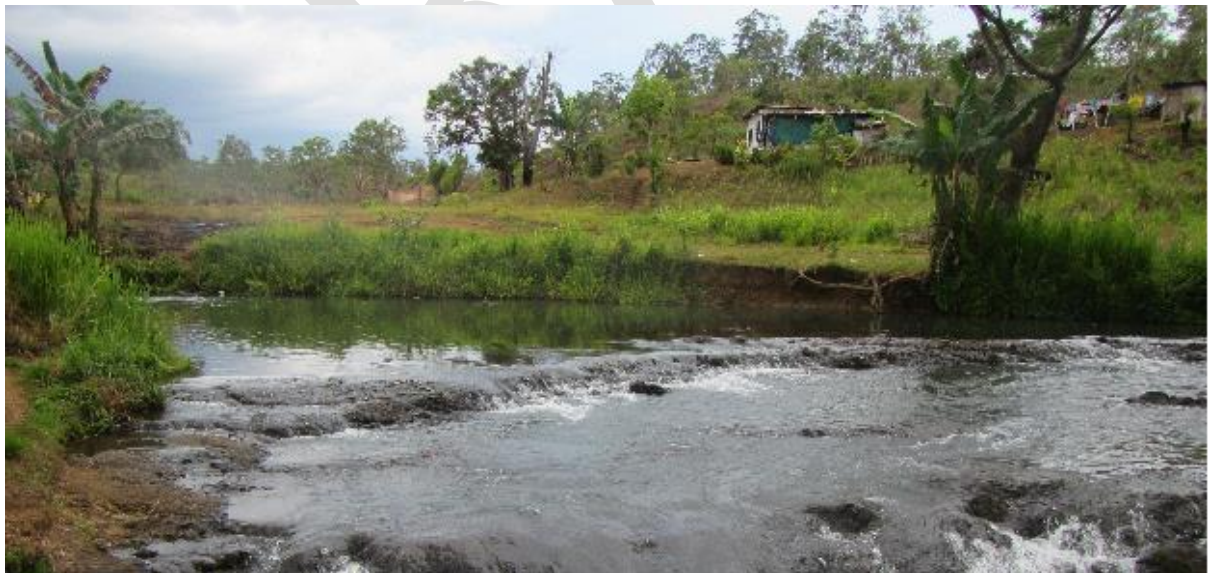
Figure 53 As shown above, the Laloki River downstream of Sirinumu Dam features prominent bedrock controls. Riparian vegetation has been cleared in sections to support river-side settlement.

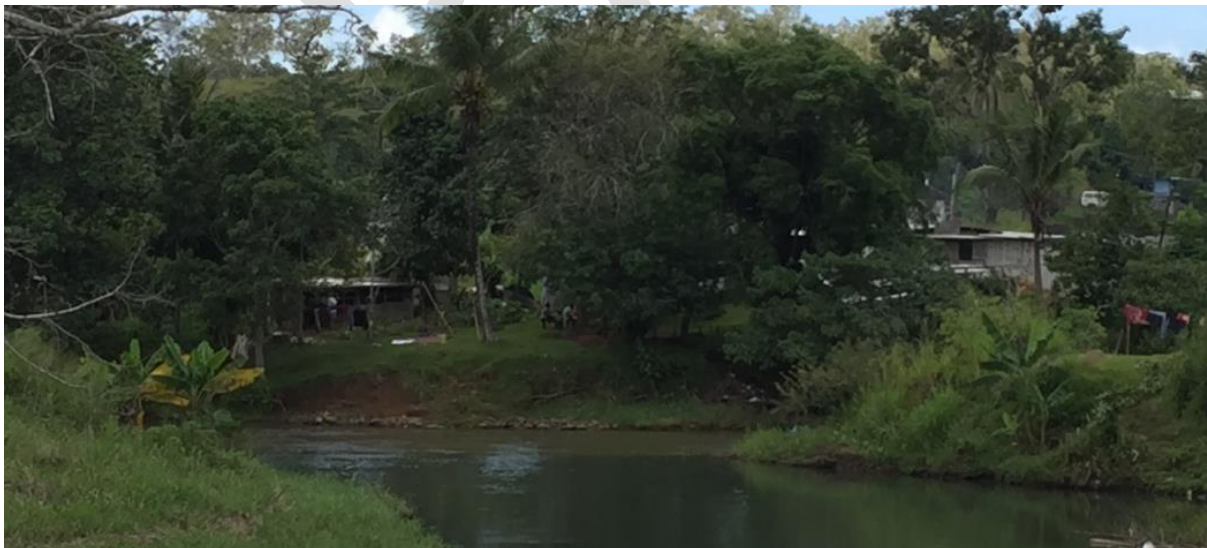
Figure 55 A distinct difference in the stream colour in March 2019 post rainfall, with Eilogo Creek brown in the background and the Laloki River in the foreground with a clearer green.

The lower Laloki River flows through a range of valley settings as shown in Figure 62. At its confluence with Eilogo Creek, there was a distinct difference in the colour of the water between both streams during the wet season (March 2019), suggesting a relatively higher contribution of suspended sediment by Eilogo Creek during this time (Figure 55). From this initial confluence, the Laloki River bears isolated zones of discontinuous floodplain deposits where sediments are stored (and eroded). Confining exposures of Astrolabe Agglomerate (Figure 56) increase in frequency as the river reaches Rouna Dam, near Rouna Falls.

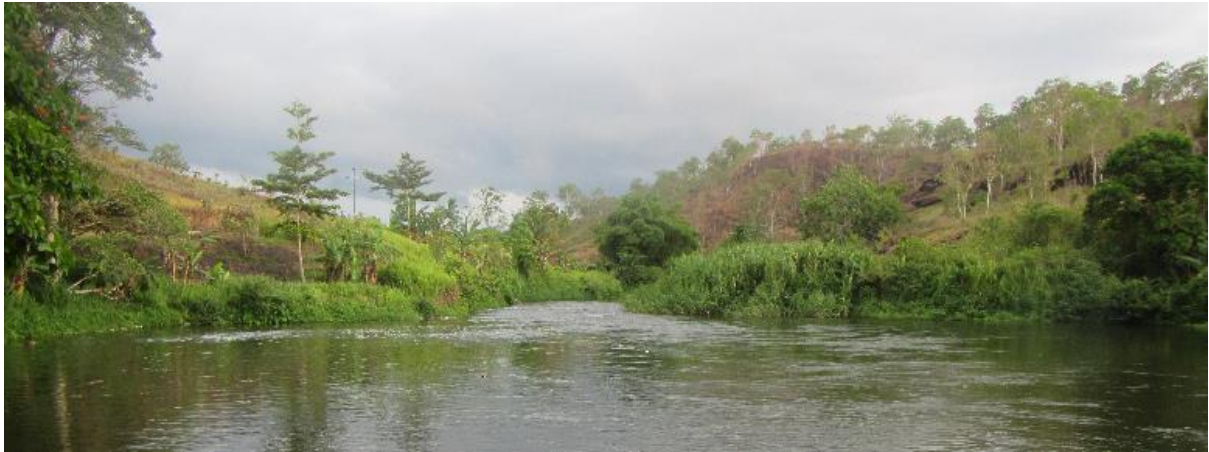
Figure 56 *The partly confined Laloki downstream of Sogeri.*

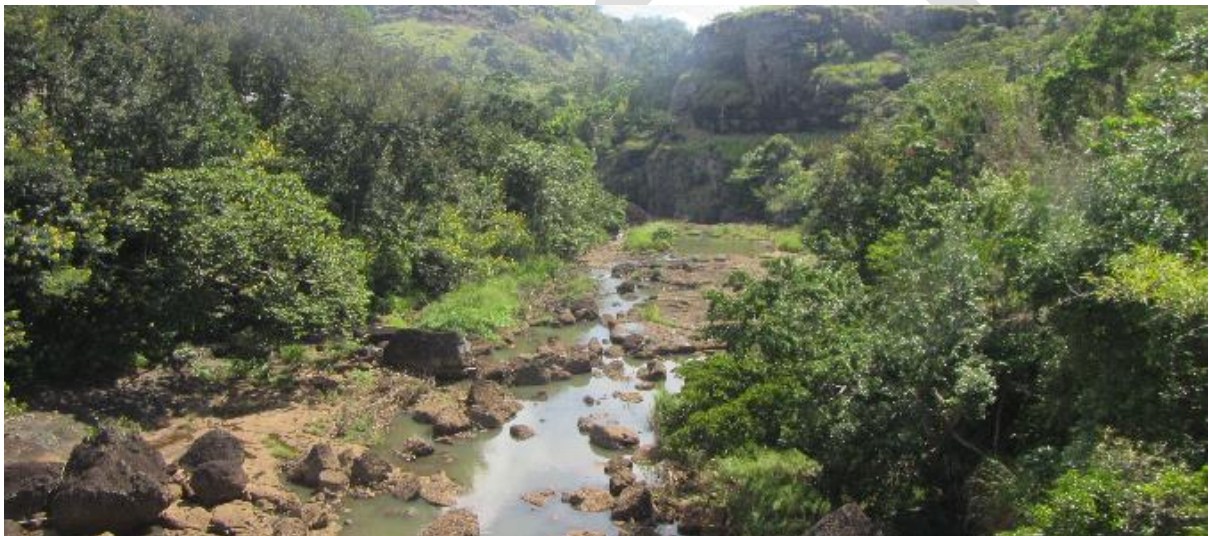
Figure 57 *Exposed bedrock above Rouna Falls downstream of Rouna Dam.*

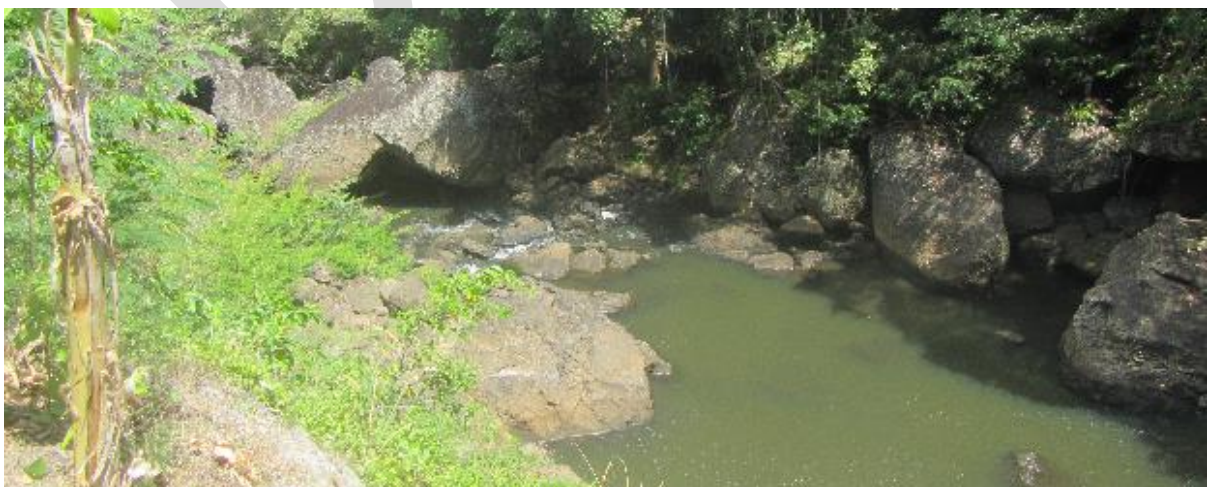
Figure 58 *Large boulders within Rouna Gorge with very little opportunity for sedimentation*

Below Rouna Dam, the river bed is scoured, leaving only minor deposits of sand amidst bedrock and boulders (Figure 57). Below the falls, the confined and steep gorge conditions provide for high sediment transport capacity, as indicated by the lack of sand, gravel and cobble deposits (Figure 58).

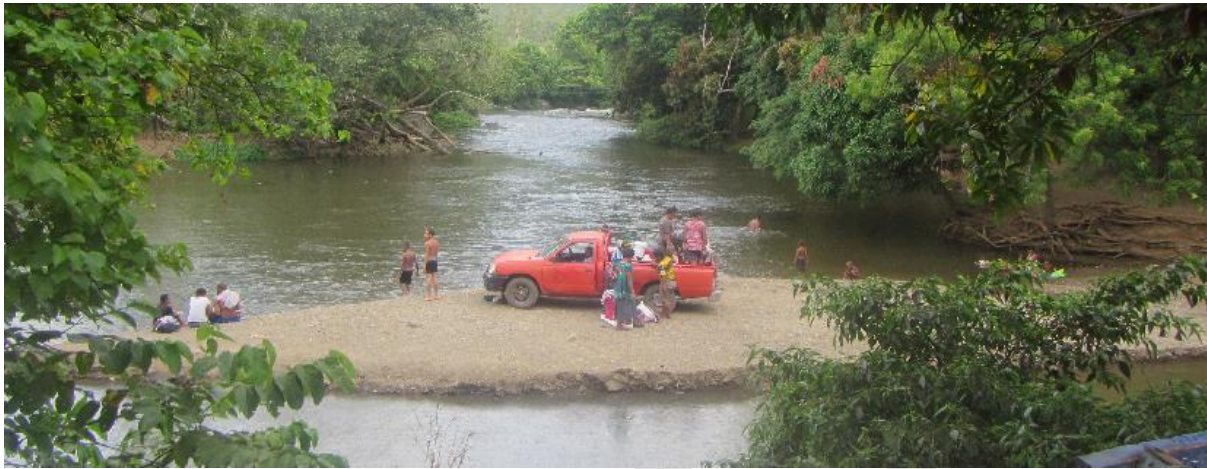
Figure 59 Alluvial gravels cobbles comprise much of the bedload along the lower Laloki River downstream of Rouna Gorge

Downstream of the gorge, the Laloki River becomes less confined. Floodplain pockets have formed where the valley floor widens, allowing for the deposition of sands and gravels and cobbles (Figure 59). As the valley floor continues to widen downstream, the floodplain deposits broaden and comprise of finer alluvial sands and clays (Figure 60) and eventually other, lighter coloured clays and sands along the Goldie River (Figure 61).

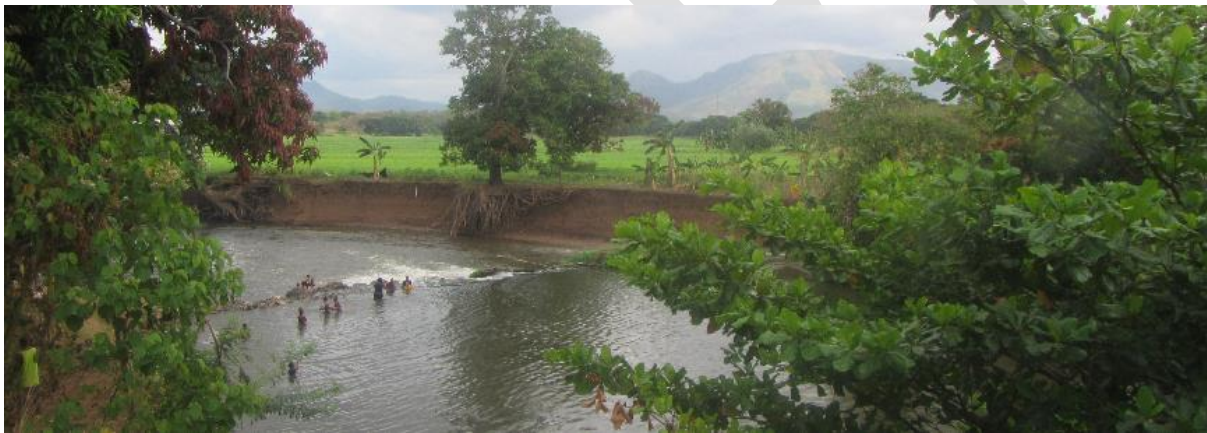
Figure 60 Expansive floodplain deposits of fine alluvial sands and clays flank the lower Laloki River valley at Bomana

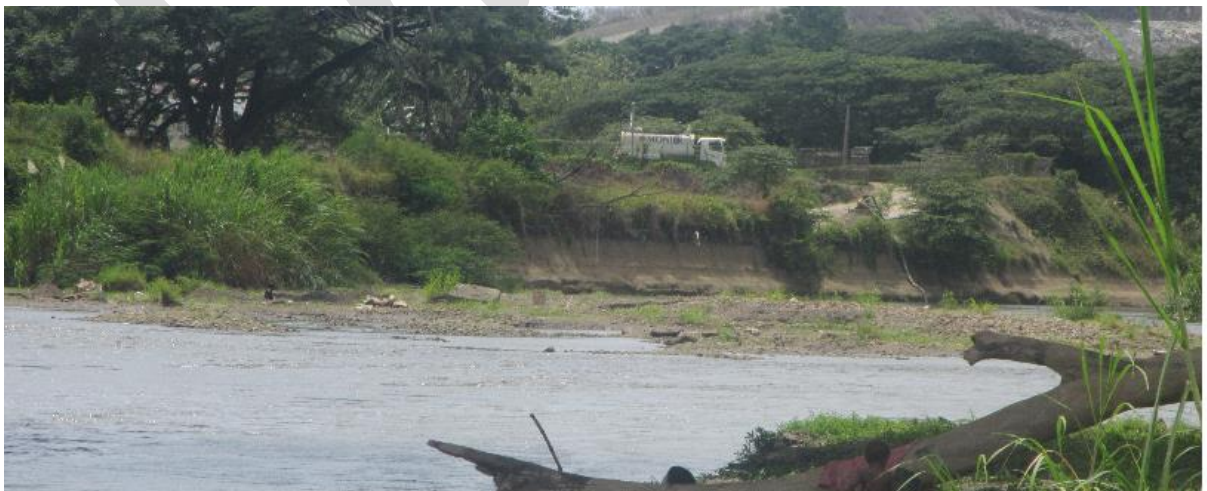
Figure 61. The Goldie River a few kilometres downstream of its confluence with the Laloki River

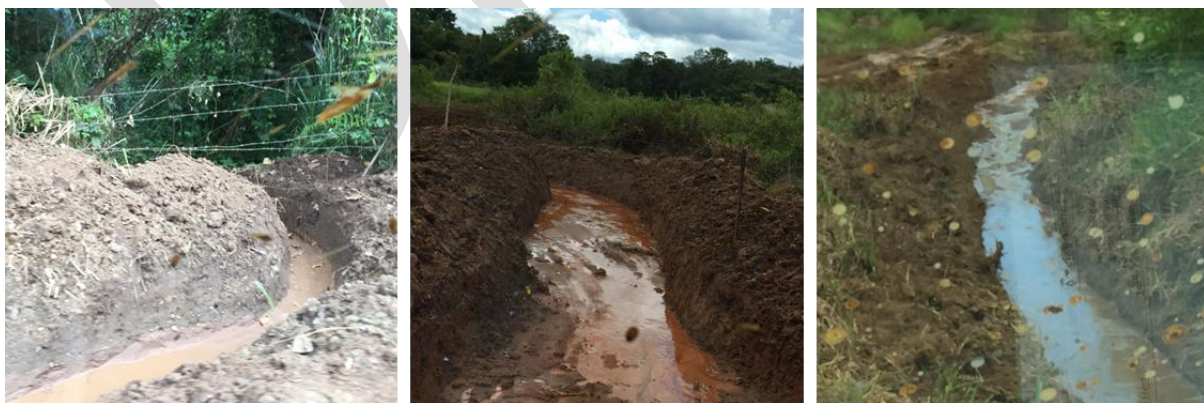
Furthermore, it was observed during this sampling period that each of these swampy, floodplain margin sections which the road cut through was recently drained in order to facilitate vehicle passage (Figure 74). In many instances, these drains extended for tens of metres towards Eilogo Creek in order to ensure removal of excess water and mud. It is highly likely that these drains contribute high sediment loads to the waterway.

Figure 74 A sample of the multiple drains dug in order to facilitate road drainage

The assessments undertaken in this study provide for a good understanding of the sediment delivery dynamics within the catchment. Hillslope erosion is widespread across the cleared, burnt and agricultural areas, particular in the Eilogo Creek and lower Laloki sub-catchments. The fine sediments are likely to be transported in suspension to downstream receiving waters during high flow event. However, during overbank events the cohesive properties of the volcanic clays allows for a proportion of the hillslope derived sediments to drop out on the floodplain. These floodplain sediments however are susceptible to further mobilisation, through land clearing and increases in stream power generated by upstream landscape disturbance and drainage works (Figure 74).
