DRAFT SEDIMENTATION REPORT:

The Laloki River catchment

June 2019

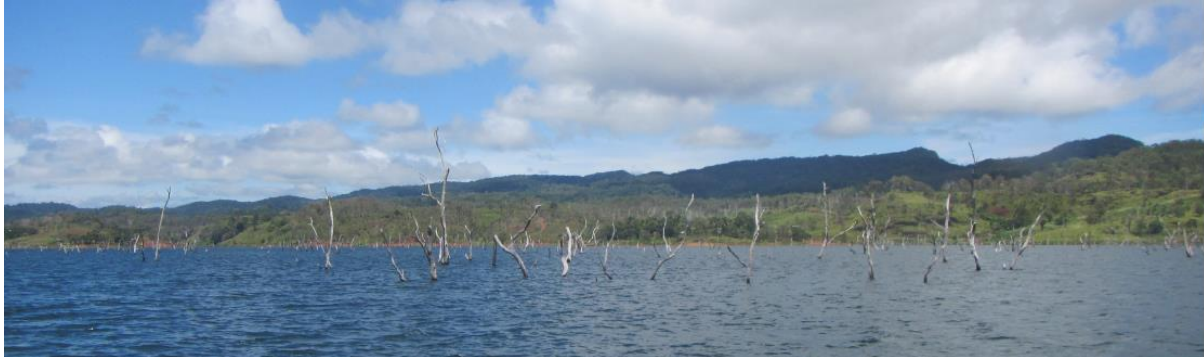
Cross sections were taken as close as possible to the 2007 survey lines, with proximity being limited by the ground conditions experienced by the survey team. The high concentration of drowned vegetation along the reservoir floor combined with reduced reservoir levels (3.5 m lower than during the 2007 survey) made navigation along the designated points near impossible (Figure 10). Time on the water was also limited by dam access being restricted by poor weather and road conditions, limiting each section to a single beam survey.

Figure 10 Numerous trees remain standing in the reservoir, restricting navigation

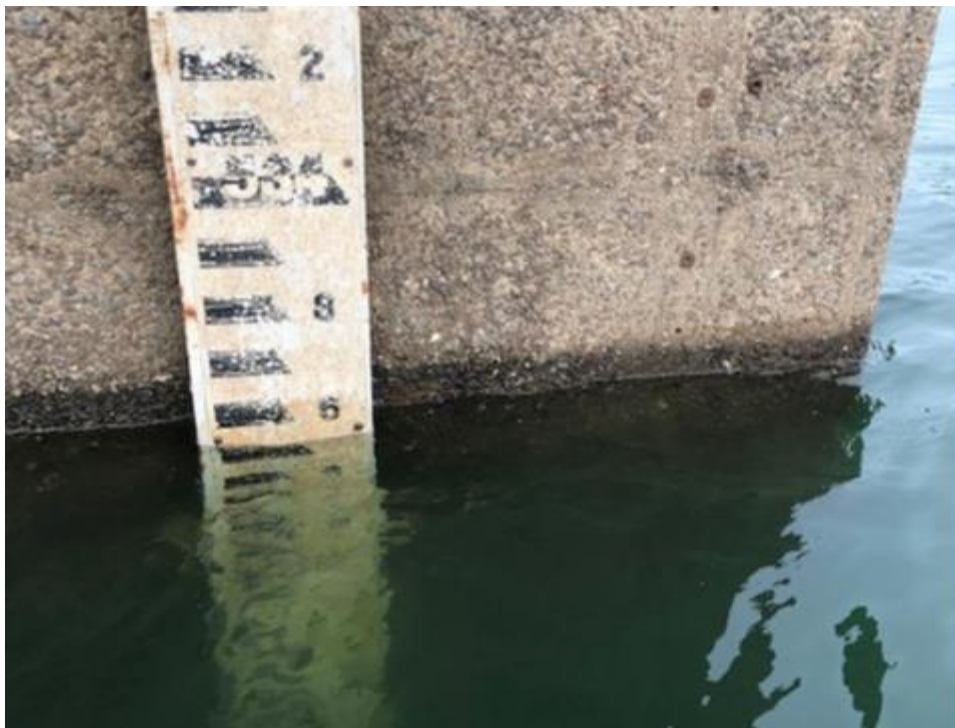
The dam level during the time of survey was recorded at the beginning and end of each survey at 533.5m. This level did not change for the duration of the survey period (Figure 11). A total of ten bathymetry profiles representing 16.5 kilometres of data were collected.

Figure 11 A snapshot of the reservoir water level of 533.5 m which did not change for the duration of the survey period.

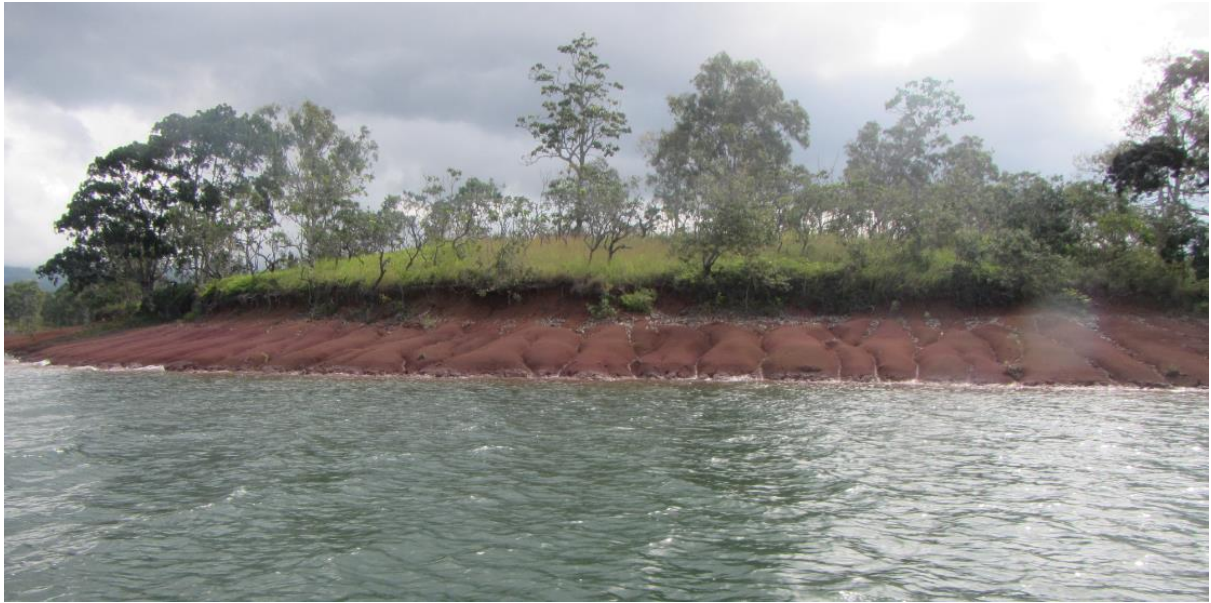
- A mechanism with potential to move sediment within the dam is likely to be due wind generated wave erosion in locations where there is a large fetch or on islands subject to variable inundation depths without vegetation cover. The impact of this sediment source on overall storage capacity is likely to be negligible as it is only re-distributing sediment within the dam.

Figure 13 . Evidence of active erosion within the dam most likely due to wind wave action

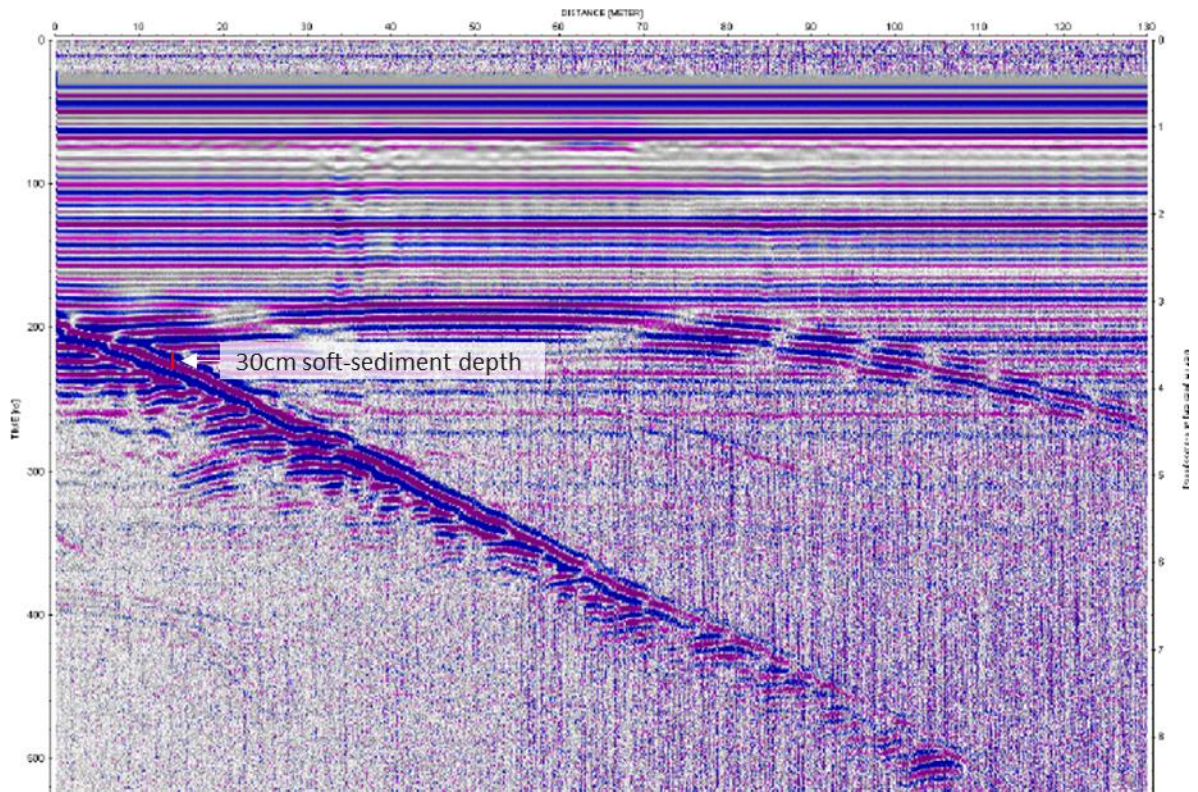
Figure 42 The far left (western) end of the CS7 indicates a soft sediment depth of approximately 30cm.
