# Environmental Monitoring Report

Final Report  
January - December 2014

## Papua New Guinea: Lae Port Development Project

## Lae Port Tidal Basin Development Project Phase I January – December 2014 Environmental Report

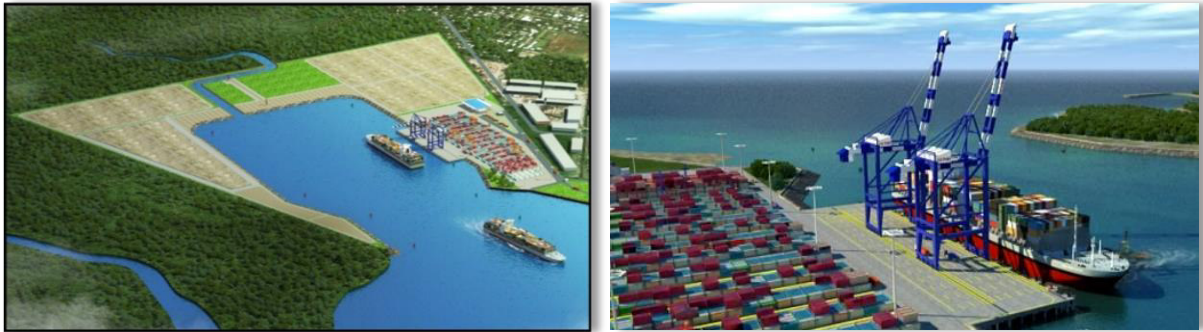
Figure 2-1 Tidal Basin Phase 1, Wharf and Berthing Facilities, Cranes and Container Storage

16. The Lae Port Development Project – Tidal Basin Phase 1 comprises one basin 400m x 700m, one berth of length of 240m for one 50,000 tonne DWT container vessels, a 120,000m<sup>2</sup> container terminal yard, a link road, terminal buildings, utilities, and support facilities. When finished it will look as shown in the artists impression in Figure 2-1.

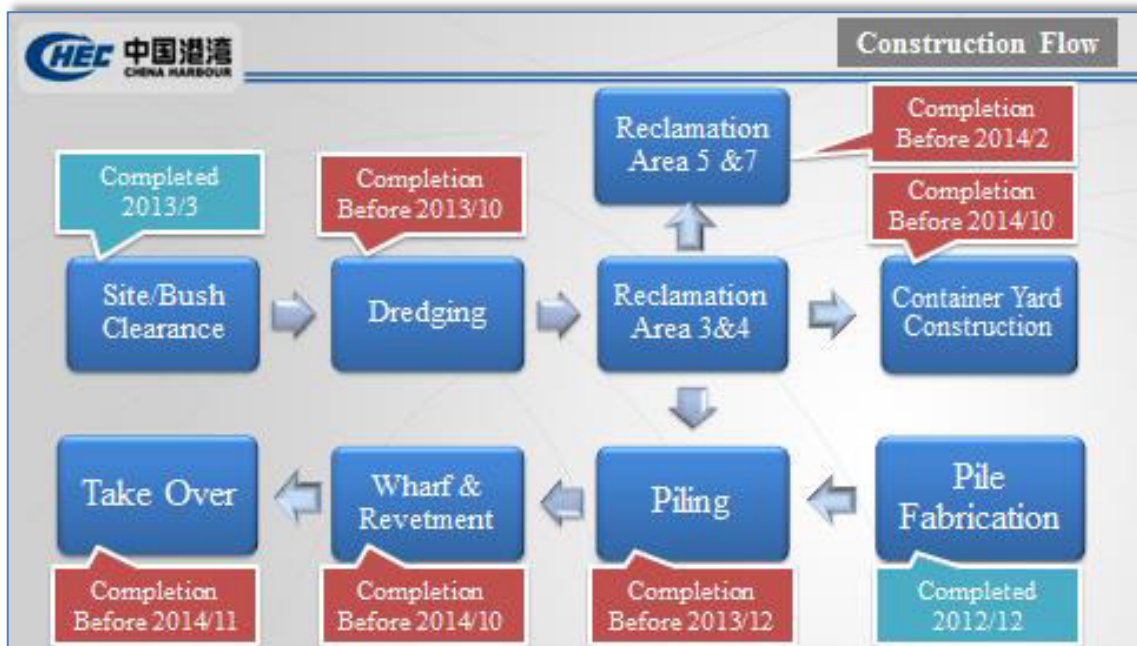
Figure 2-3 Construction Program

20. The major activities as planned in the construction program are shown in Figure 1.4 below. This indicates achieved and anticipated completion dates.

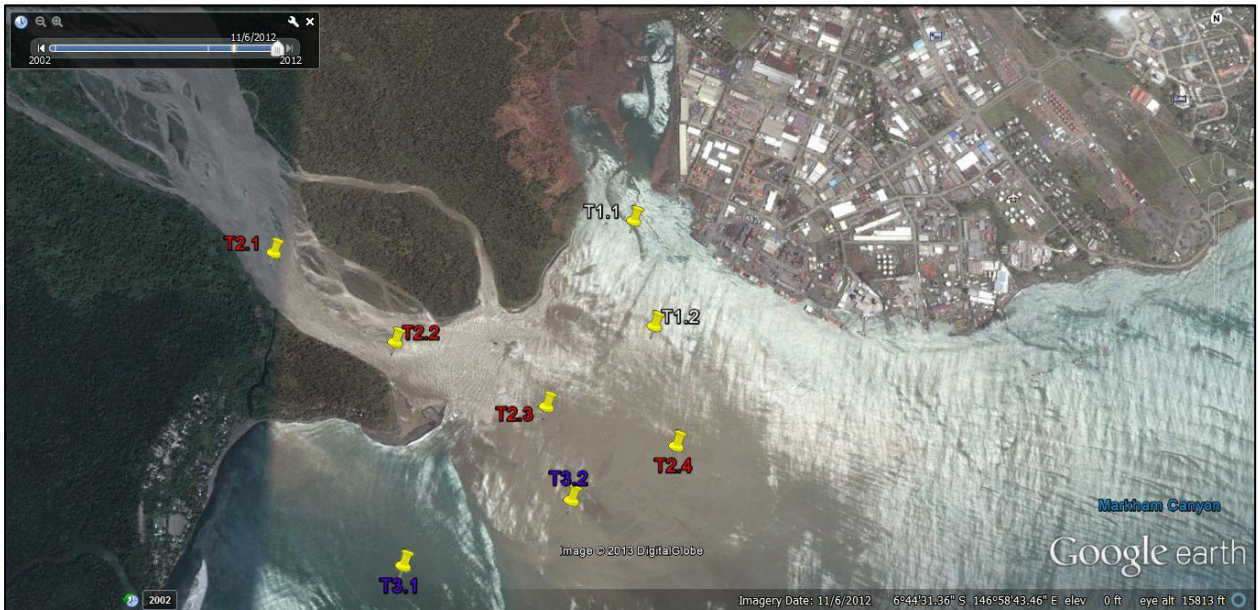
Figure 6-1 Transects 1,2 and 3

58. As stated in the CEMP sampling takes place along 4 transects named Transects 1, 2, 3, and 4. Water samples were taken every 500m along transects 1, 2 and 3 and every 5,000 m along transect 4. The location of transect 1, 2, and 3 is indicated in Figure 6-1 below. Transect 4 runs from Labu Bay to Busama and Salamaua covering a distance of approximately 50km and samples are taken at a distance of 50m from the coastline. Positioning of the sampling stations was carried out by means of global positioning system device (Garmin Etrex 20). All samples were obtained at 1.5m depth below the water surface.

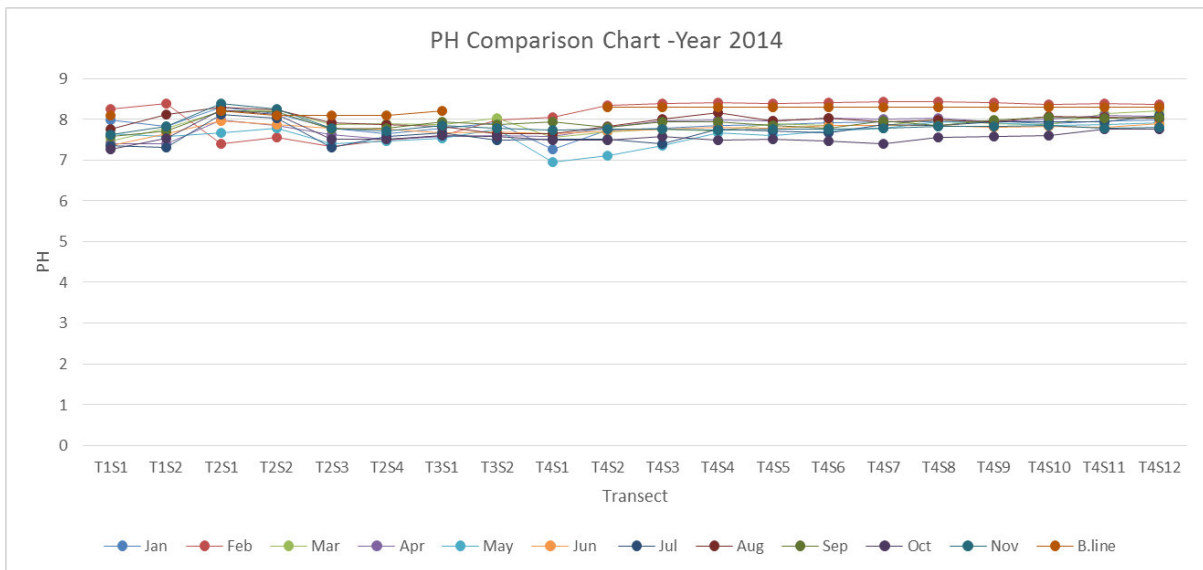
Figure 7-2 pH

70. The values of pH were very consistent remaining around pH8. There was no seasonal variation and no difference from the baseline values. It is considered that the seawater being saline has a large buffering effect on the freshwater inflows from the Markham River.

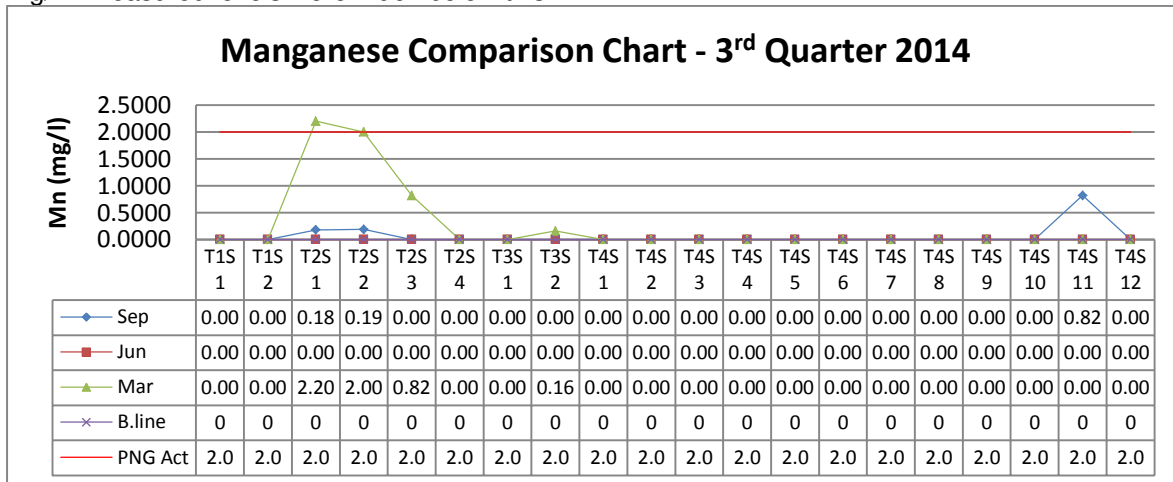
Figure 8-14 Manganese

93. Manganese was detected in very low concentrations. The PNG standard for manganese is 2.0 mg/L. Measured levels were much below this.

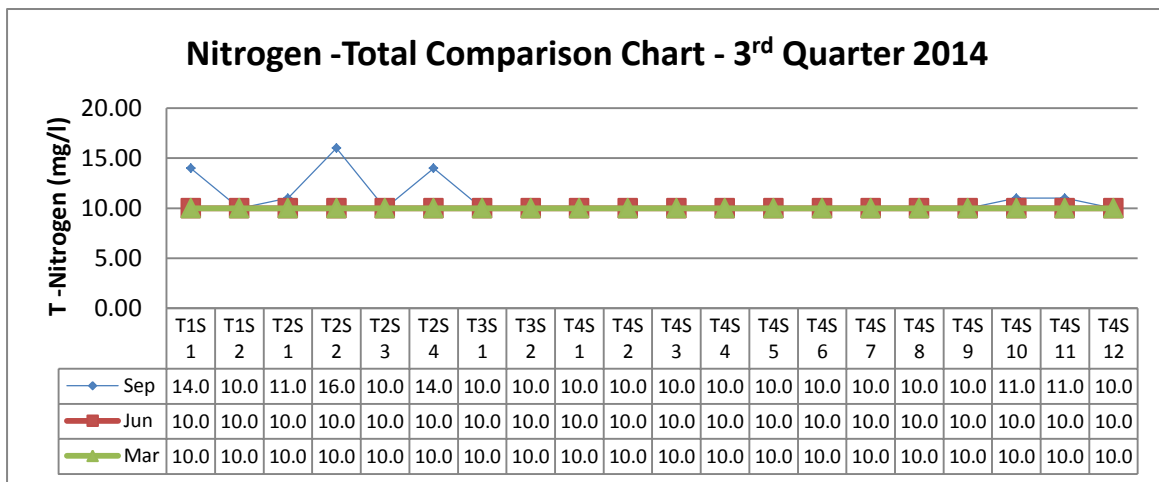
Figure 8-18 Nitrogen

97. Nitrogen was detected at levels similar to March and June. Levels were very consistent. There is no standard for nitrogen in seawater in PNG.

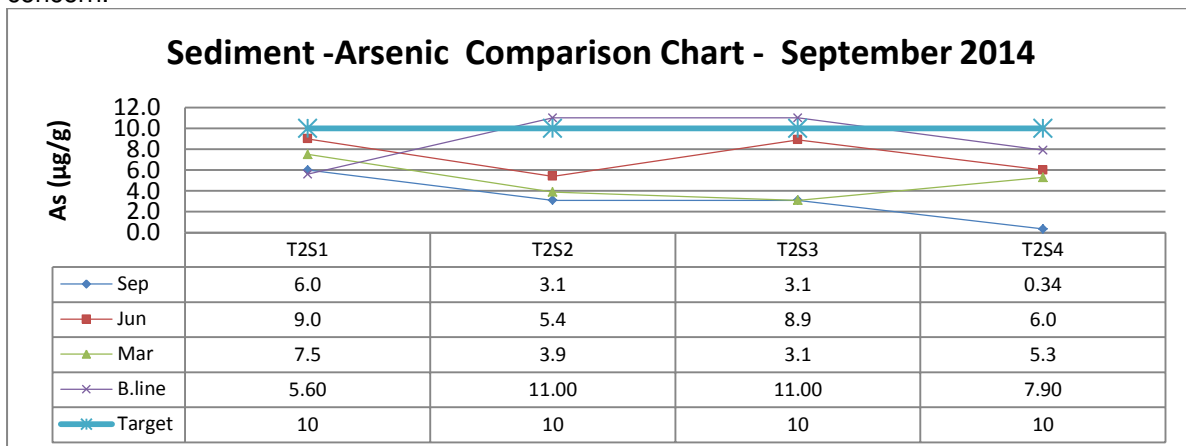
Figure 10-3 Arsenic

114. The levels for arsenic were below the target level and below the baseline except for T2S1. The baseline had been similar to the target levels. The standard for arsenic is 10 ug/gm in sediments. Arsenic deposits may be due to upstream gold mining. Arsenic levels have dropped and are not of concern.

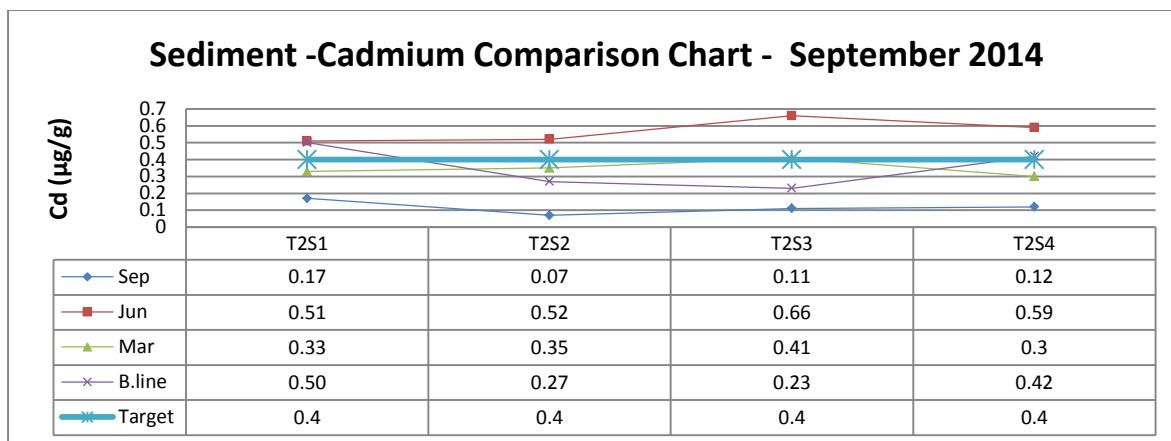
Figure 10-5 Cadmium

116. Cadmium levels were below the baseline and below the standard. The standard for cadmium is 0.4 ug/gm in sediments. In September all levels were within the standard.

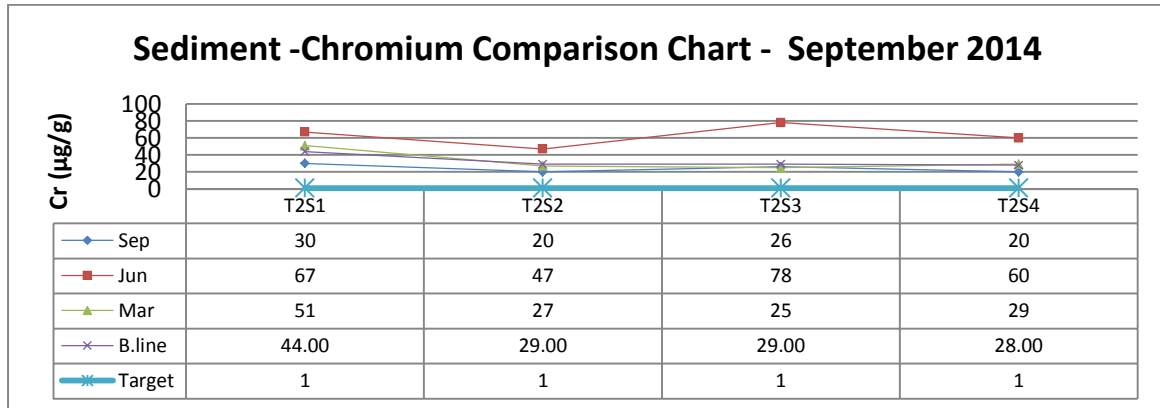
Figure 10-7 Chromium

118. Chromium levels in September were similar to the baseline and significantly above the standard. The standard for chromium is 1.0 ug/gm in sediments. Levels were elevated in the upper reaches of the Markham River suggesting the source is inland not coming from the site.

140. River bed sediment samples did not show signs of significant contamination. Metals of concern are antimony, chromium, copper, lead, nickel and vanadium. All other metals were at low levels. These metals are associated with corrosion prevention of ships and could be originating from vessels hulls. Copper could originate from the upstream gold mining as gold and copper are usually found in mineral deposits together. There are no site activities associated with these metals.

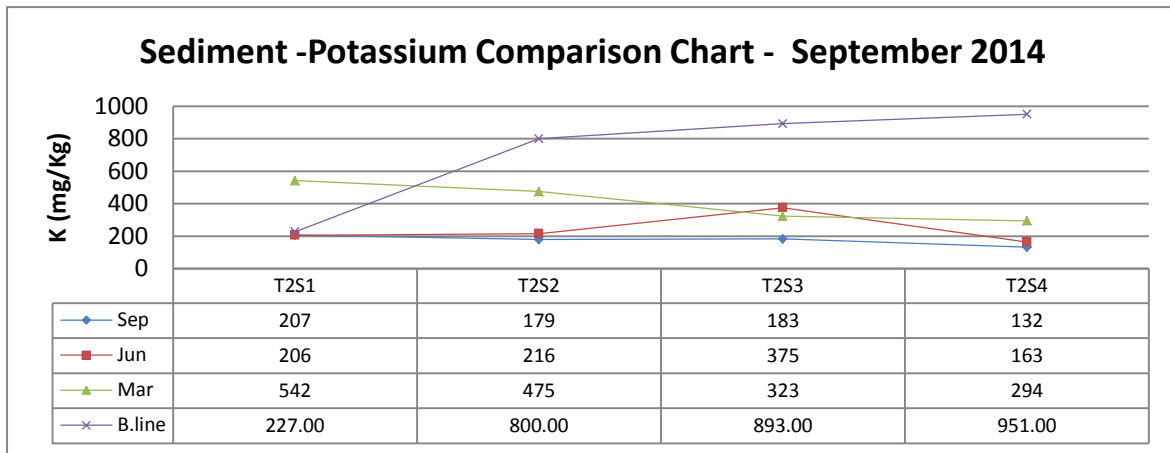
Figure 10-20 Potassium

131. Levels of potassium were lower than the baseline. As potassium is associated with chemical fertilisers this could be land based run off from rainfall. There is no standard for potassium in sediments.

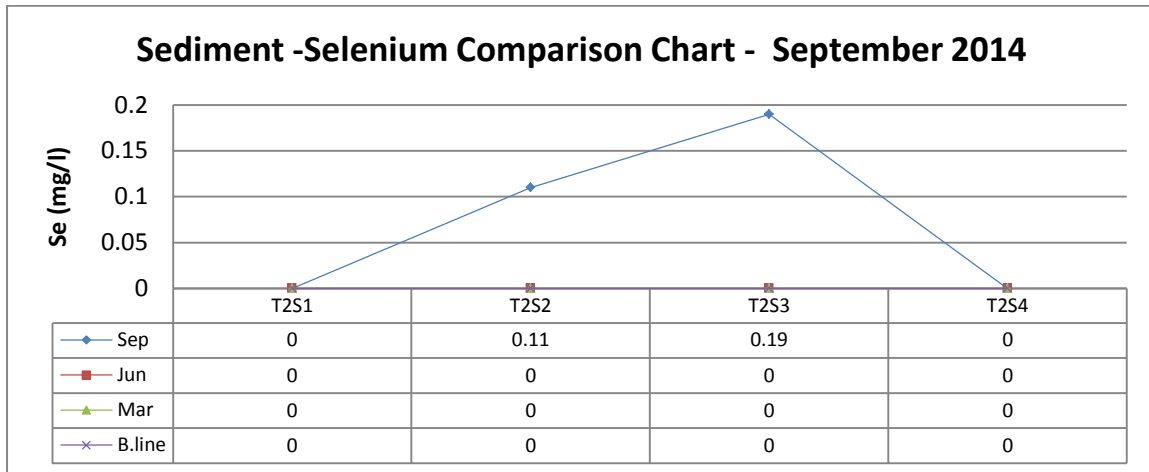
Figure 10-23 Selenium

134. Selenium levels were either not detected or on the limit of detection. They were similar to the baseline. The standard for selenium is 0.07 ug/gm in sediment. Levels at T2S3 were elevated. There is no apparent reason for this.
